Radon Reduction in Crawl Space House

EPA/600/J-89/078

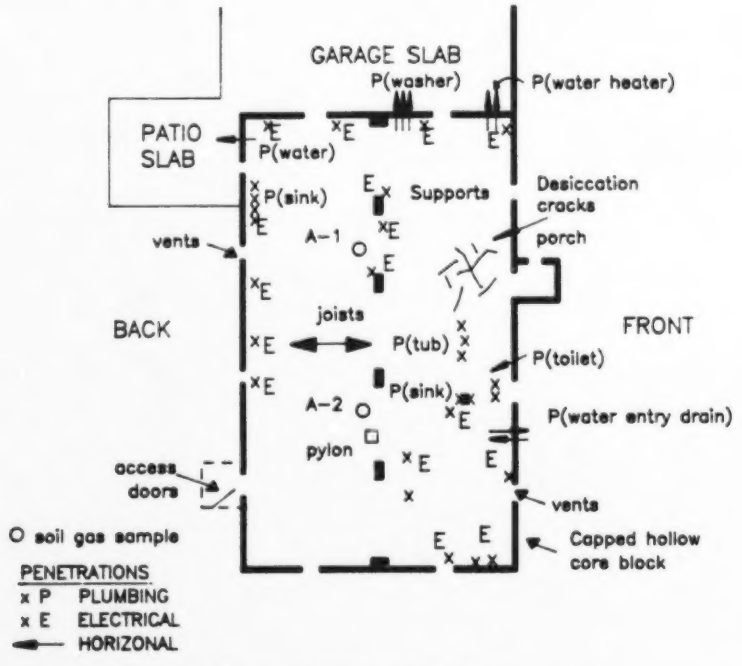
FIG. 1. Diagram of a Crawl Space

The residence which was selected for a detailed mitigation study was relatively free of complicating factors. The house is located in Hermitage, Tennessee, and is an 1,100-sq ft (102.2-m^2) ranch style house built in 1962. It is a brick structure with a hollow core block foundation. The height of the foundation wall varies from 24 to 40 in. (0.61 to 1.02 m). The house is heated by a radiant heat system in the ceiling and cooled by a window air conditioner (no ductwork). Foundation vent cover plates and a tight-fitting access door allow good sealing of the crawl space area. Major radon entry points into the living area from the crawl space are limited to plumbing penetrations, including a 6 × 10-in. (15.2 × 25.4-cm) hole under the bathroom tub and electrical penetrations. A diagram of the crawl space is shown in Fig. 1.

Bare soil was exposed in the crawl space (no moisture barrier). It is A and B horizon Maury loam, a phosphatic, clayey-silty soil derived from the Middle Ordovician Bigby-Cannon formation. Desiccation cracks up to 1/4 in. (0.64 cm) wide are present in parts of the crawl space.

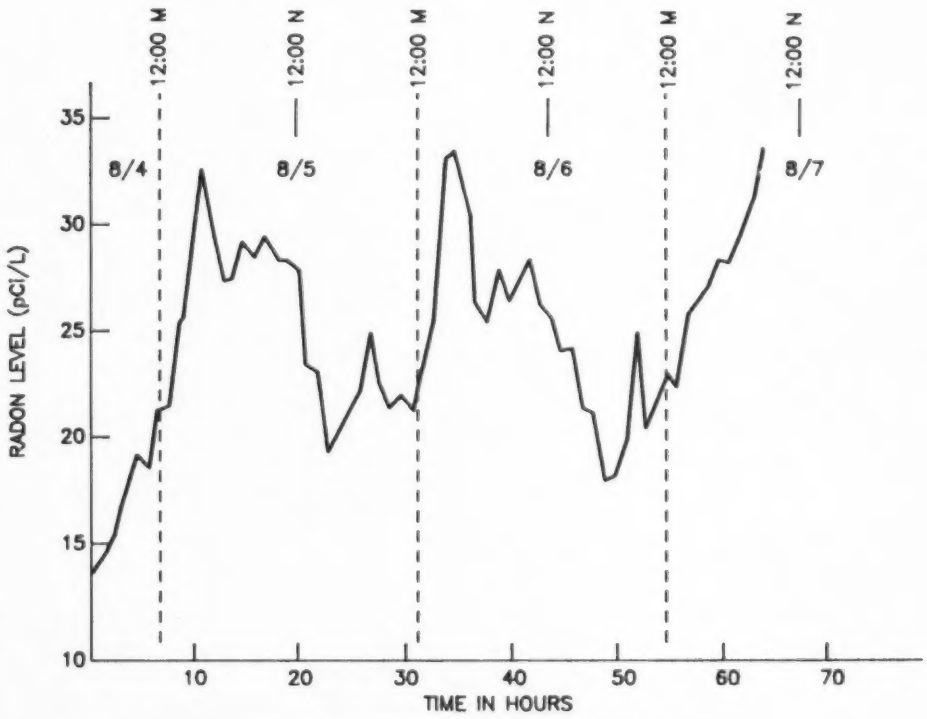
FIG. 2. Premitigation Radon Levels, Crawl Space

The CR test showed an average radon level of 25.3 pCi/L in the crawl space, with a low of 18.1 pCi/L and a high of 33.7 pCi/L (Fig. 2). The Pylon intake was 1 ft above the crawl space floor. The soil samples showed 130.5 and 143.2 pCi/L. The sample from the desiccation crack showed 42.2 pCi/L. Short count grab samples and activated carbon tests of the living area showed 3.0 pCi/L or less. A slightly higher value was found in the bathroom linen closet (3.3 pCi/L) and extracted from an electrical outlet in a closed-off bedroom (4.3 pCi/L).

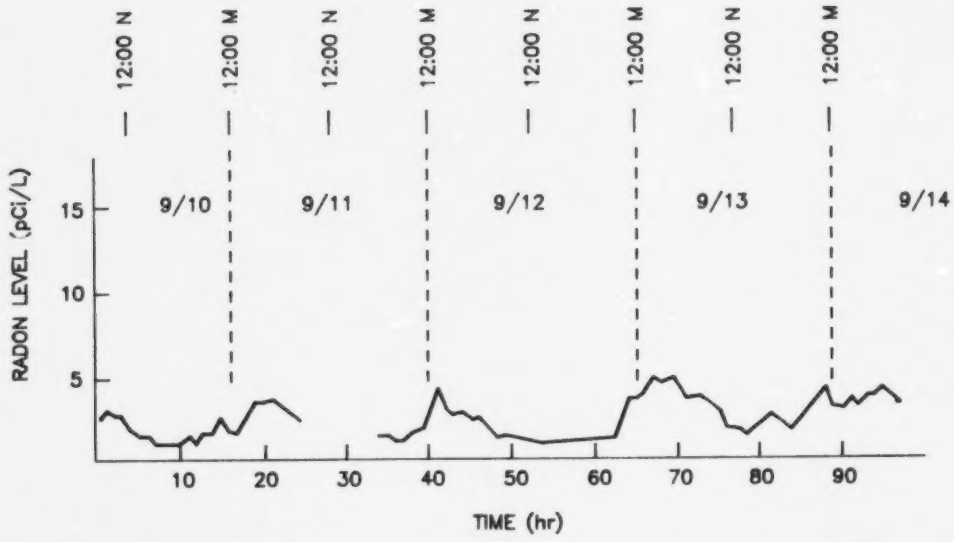
FIG. 3. Radon Levels, Crawl Space, Subplastic Suction, Foundation Vents Closed

the premitigation average of 25.3 pCi/L to an average of 2.2 pCi/L (Fig. 3). With the foundation vents open, the radon level was lowered further, averaging 1.5 pCI/L.

Next, the plastic film was sealed over the crawl space floor and the sub-plastic suction system installed. When suction was applied to the system, radon levels in the crawl space (foundation vents closed) were reduced from

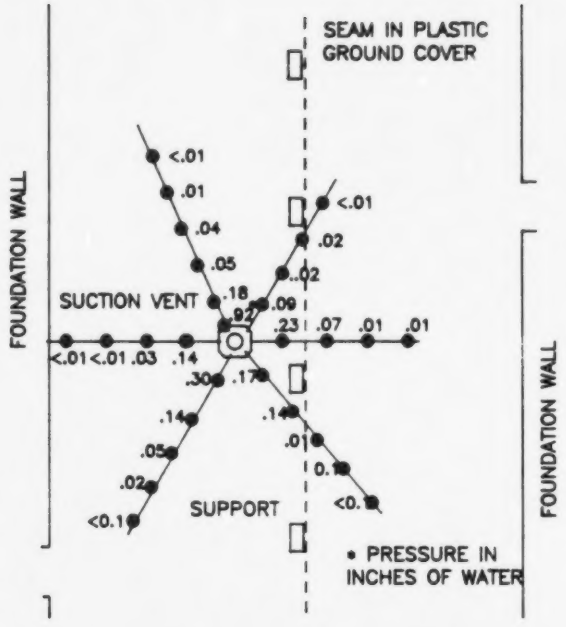
FIG. 4. Subplastic Depressurization, Crawl Space

The exhaust rate and static pressures in the vent system and below the plastic film were measured after 72 h of continuous fan operation. The exhaust rate, measured on the roof with an air bag, was 36.3 cfm (61.7 m^3/hr), well below the maximum capacity of the fan. The static pressure in the exhaust vent, measured in the attic at the fan inlet, was 0.96 in. (2.34 cm) of water. Pressure in the vent 2 ft (0.61 m) above the crawl space floor had dropped to 0.92 in. (2.34 cm) of water and held at 0.92 in. (2.34 cm) of water in the gap just below the suction vent. Static pressures under the plastic film showed a sharp drop from the vent, declining to less than 0.01 in. (0.254 mm) of water at distances of 8–10 ft (2.44–3.05 m) from the vent. A subplastic pressure diagram is shown in Fig. 4.
